ADMAT Undertakes a DGPS’s Survey of The Purton Hulks In The UK

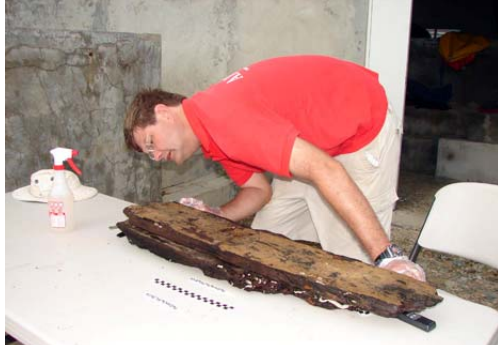
Photograph 20: Dr. Spooner analysing the sacrificial planking and removing a sample of the paint to send to Paris (© ADMAT - Nielsen).

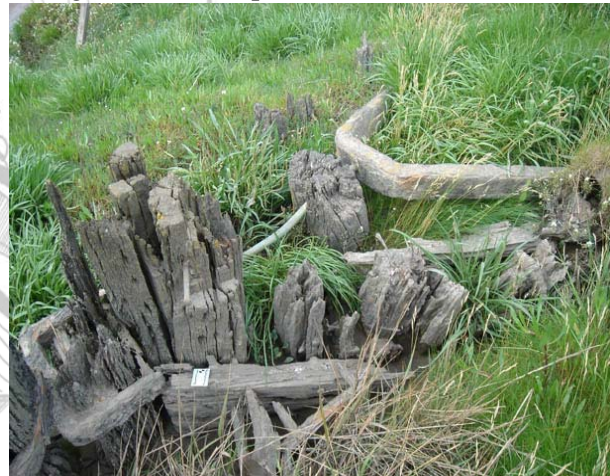
Photograph 23: The rudder and sternpost of one of the schooners at Purton in England (© ADMAT - Spooner).
