Severn Estuary Rapid Coastal Zone
Assessment Survey:
Purton Hulks Aerial Photographic
Progression Study

(English Heritage Project No. 3885 2a PILOT)

Version 2.3 – Final

2010

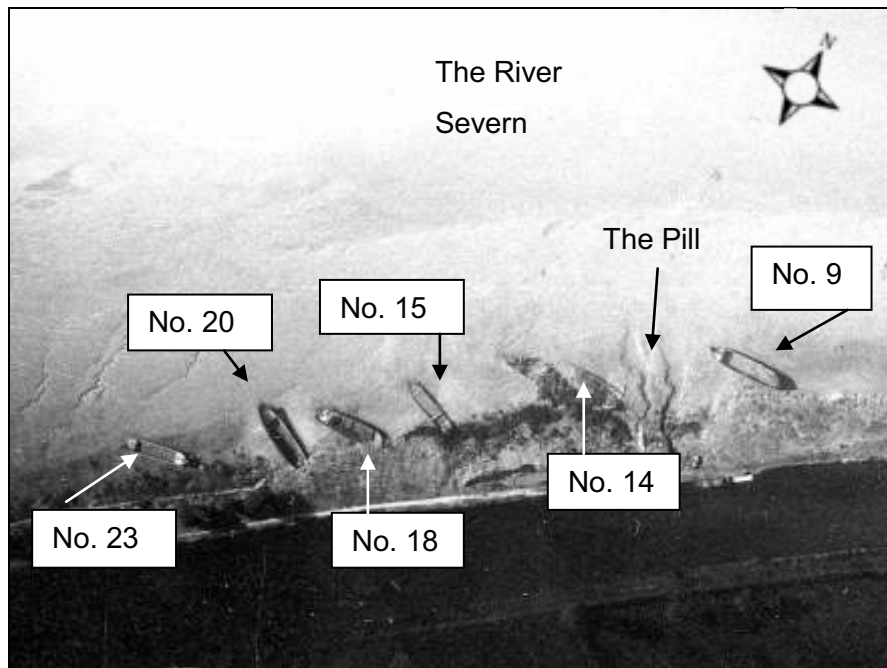
Figure 4. Photograph of vessels in 1945.

Six of the vessels at Purton in 1945. The *Petrus* (No. 14) was beached to try and protect the Pill. NMR RAF/106G/UK/733 4046 26-AUG-1945 © English Heritage (NMR) RAF Photography).

In one photograph (Figure 4) it appears that The *Petrus* (No. 14) was beached earlier than some of the other vessels as it is more deeply buried in mud and vegetation. This is supported by Barnett (2008: 10), who notes that The *Petrus* was beached in 1931 in order to protect the dredging pill (arrowed on Figure 4) from erosion.

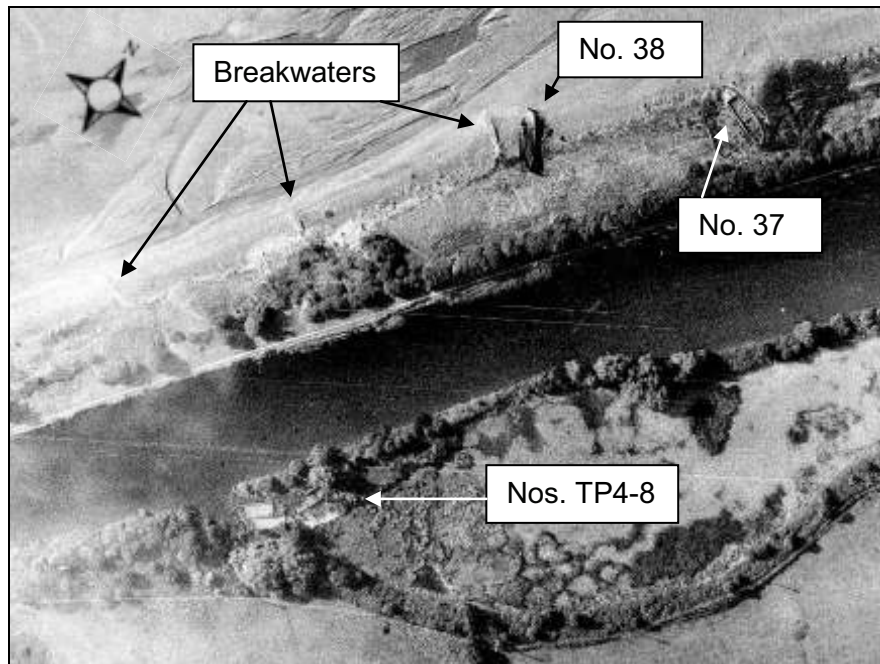
Figure 5. Photograph of vessels to the south in 1945.

This aerial photograph shows hulks Nos. 37 (*Barge Abbey*) and 38 (*Salina Jane*) to the south of Purton, as well as wrecks Nos. TP4 - 8, visible within the canal basin. (NMR RAF/106G/UK/733 3048 26-AUG-1945 © English Heritage (NMR) RAF Photography).

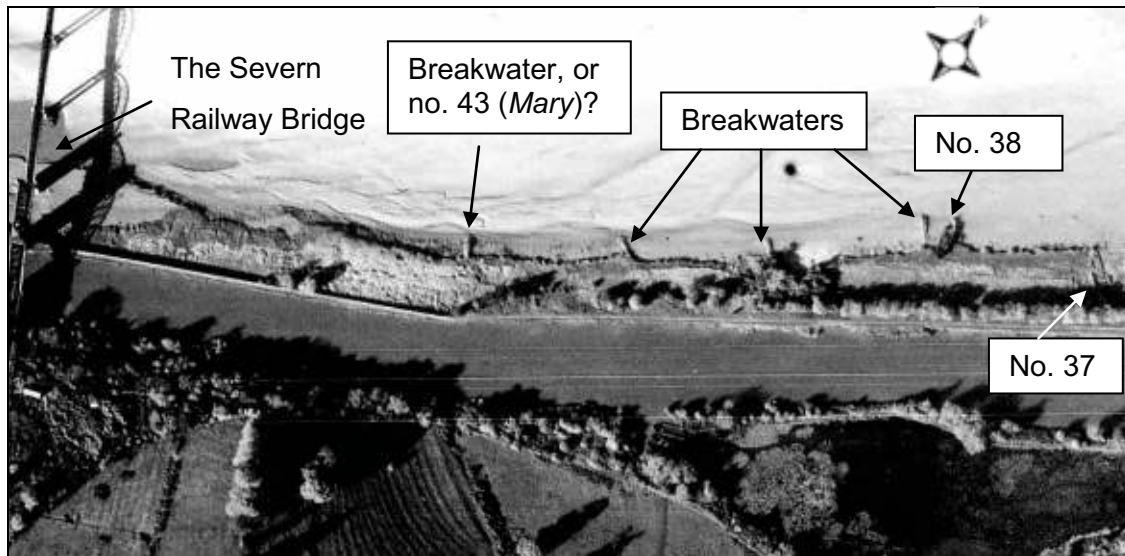
Figure 6. Purton hulks visible in 1946.

Vessels visible on an aerial photograph taken in 1946. This vertical photograph also shows at least three breakwaters down river to the south of vessel Nos. 37-38. (NMR RAF/CPE/UK/1825 4066 04-NOV-1946 © English Heritage (NMR) RAF Photography).

In 1965 Wheeler identified five vessels north of the old Severn and Wye Railway Bridge. None of these vessels was positively identified from aerial photographs, despite good examples taken in 1969 (See 4.2 for further discussion of these vessels). The hulks No. 37 and No. 38 (MacGregor's No 3 & 2) are located immediately to the north of the vessels noted by Wheeler, however, and are not only apparent on aerial photographs from 1945-1946 (Figures 5 and 6) but are still visible in 1969 (Figure 7).

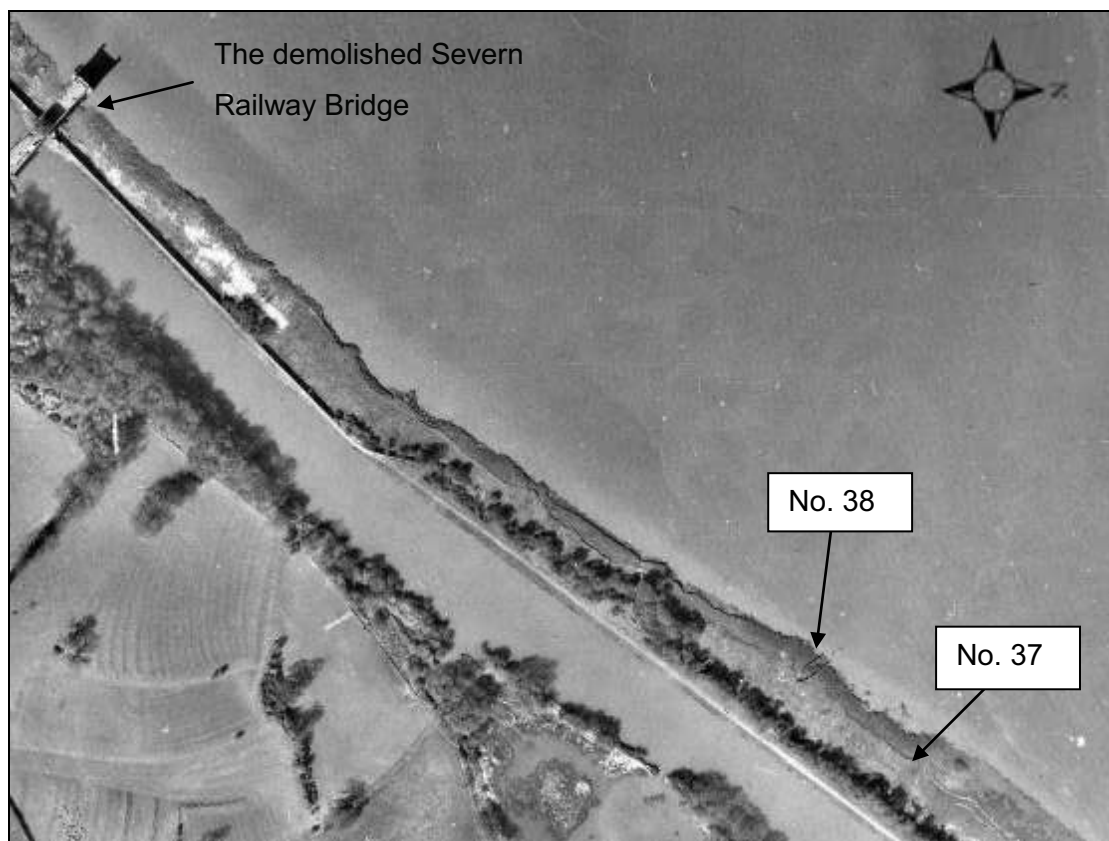
Figure 7. The breakwaters in 1969.

The breakwaters are not visible in 1969. Vessel Nos. 37-38 can still be seen. (OS/69117 155 18-APR-1969 © Crown copyright. Ordnance Survey).

Aerial photographs from 1969 (Figure 7), just four years after Wheeler's plan, show neither breakwaters nor new beached vessels, so it is possible that the hulks were buried between 1965-1969. This suggestion is supported by Barnett who states that the 1940s-60s saw this part of the site being inundated with several thousand tonnes of canal dredging and cuttings which in turn may have aided rapid vessel interment (Woodward pers. comm. to Barnett., see also Figure 14). The 1969 photographs were taken at high tide and it is therefore possible that remains of the breakwaters survived to that date but were underwater and therefore not visible.

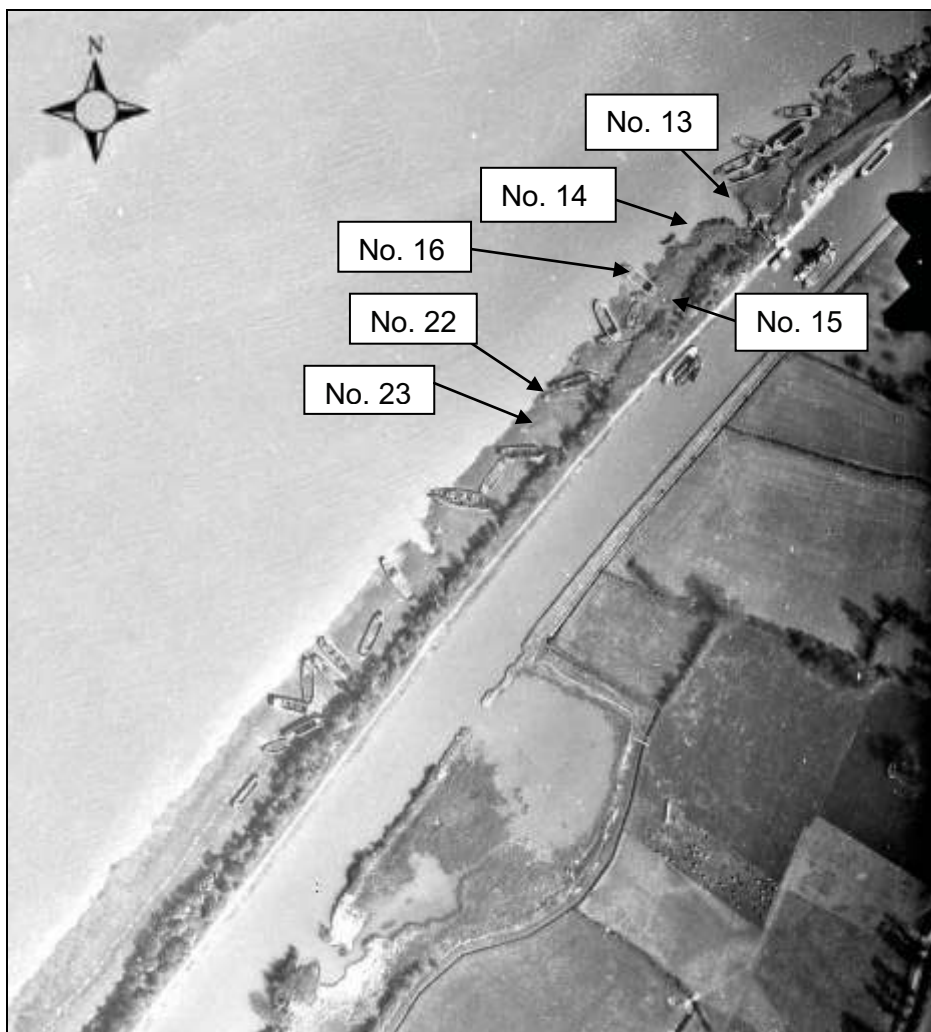
Figure 8. Purton hulks visible in 1969.

The vessels visible in 1969. Vessel Nos. 13 (*Barry*), 14 (*Petrus*), 22 (*Rockby*) and 23 (*Britannia*) are just visible, and No. 15 (*Mary Ann*) has been completely buried. (OS/69117 156 18-APR-1969 © Crown Copyright. Ordnance Survey).

The majority of vessels beached by 1946 were still visible, though some were partially buried, and Nos. 13 (*Barry*), 14 (*Petrus*), 22 (*Rockby*) and 23 (*Britannia*) were just discernible. Vessel No. 15 (*Mary Ann*) was completely buried, and hulk No. 16 (*FCB 52*) had been placed on top of it (Figure 8).

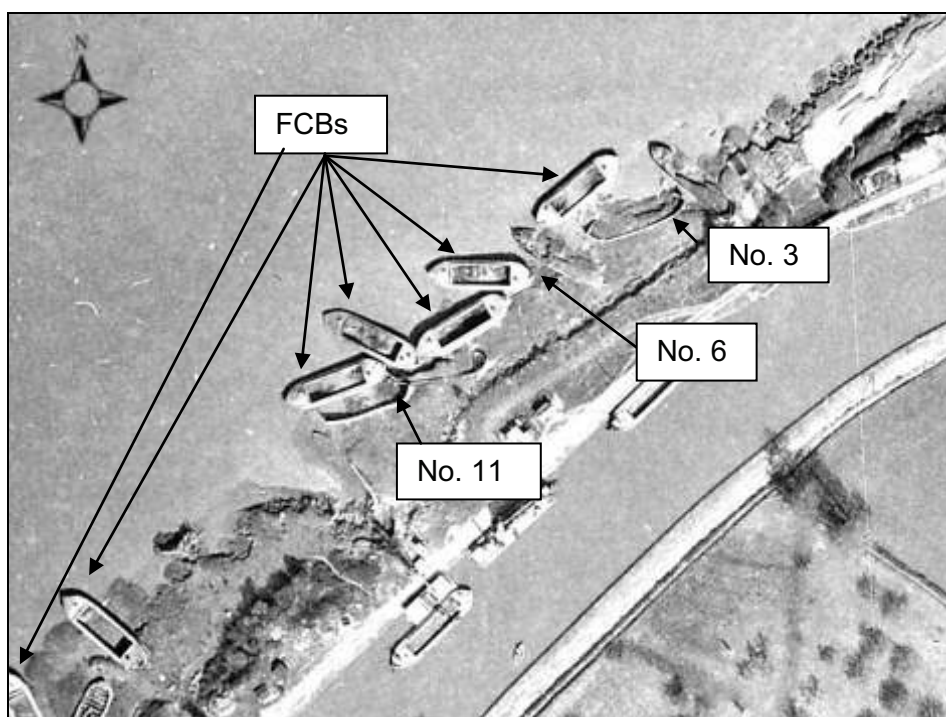
Figure 9. FCBs and partially buried vessels.

This 1969 aerial photograph shows the Ferrous Concrete Lighters beached in 1963-1965. Timber vessel Nos. 3 (*Newark*), 6 (*40 ton Flat*) and 11 (*J & A. R*) were first visible in 1969, but were already largely buried. (OS/69117 234 18-APR-1969 © Crown Copyright. Ordnance Survey).

Many of the vessels beached after 1947 were Ferrous Concrete Barges (FCBs), seven of which were visible in 1969 (Figure 9). Built in 1941 in order to replace steel harbour lighters lost in the Second World War, they were finally run aground in 1963-1965 (Barnett 2008: 7-8). Vessel No. 16 (*FCB 52*) was re-floated and moved to the National Waterways Museum on 29th March 1990 (Hugh Conway Jones pers. comm. to Barnett

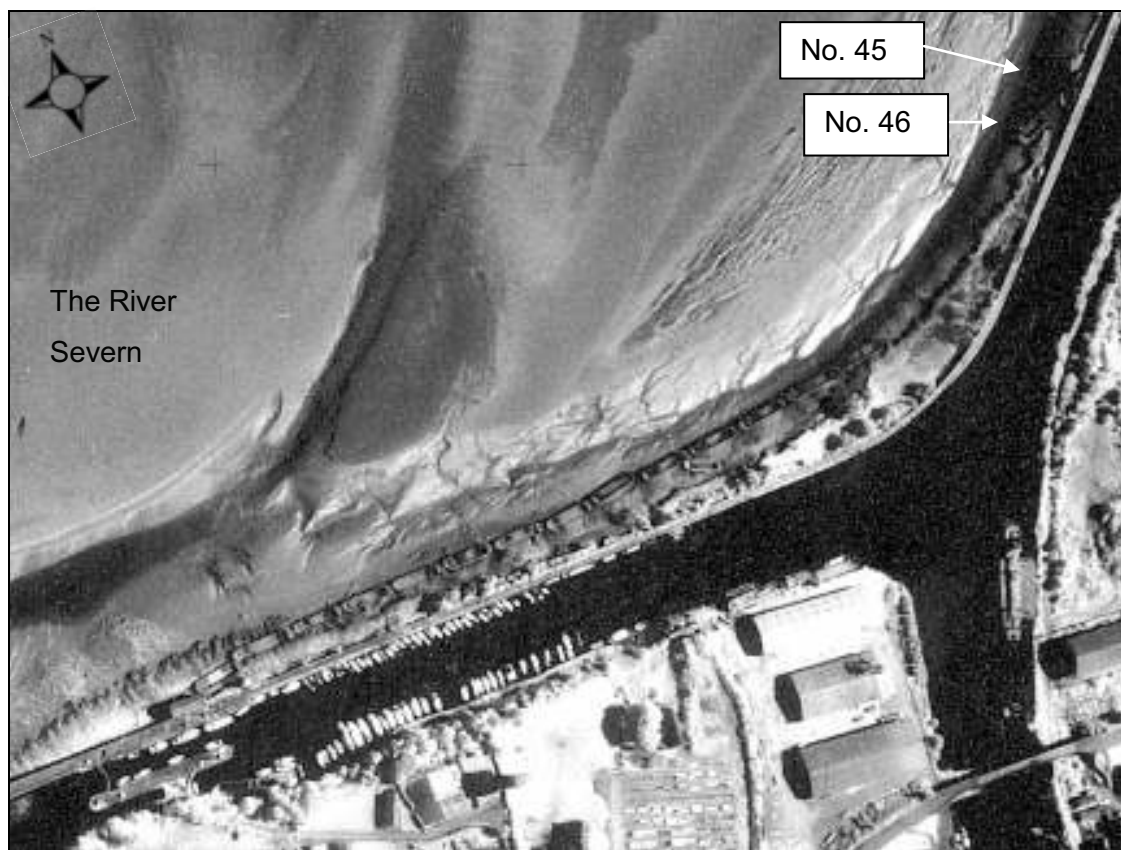
Figure 10. The Sharpness hulks in 1979.

The hulks visible on the Sharpness foreshore on a 1979 aerial photograph. Vessels No. 45 (*Severn Conveyor*) and No. 46 (*Lighter No. 9*) are just discernable in the upper right corner of the image. (OS/79034 026 19-MAY-1979© Crown Copyright. Ordnance Survey).

The vessels on the Sharpness foreshore were first beached during 1971-1973, in order to protect the canal's retaining wall from the Severn Estuary's erosive tidal forces (Barnett 2008: 6). The vessels were mainly beached end to end to form a linear barrier (Figure 10). Most were redundant River Lighters and Steel Lighters. All of these vessels (No. 45 - *Severn Conveyor* to No. 61 - *Lighter No 23*) were still clearly visible on the Sharpness foreshore on recent aerial photographs, although they are now being inundated and vegetation has grown over many vessels as the foreshore has stabilised.

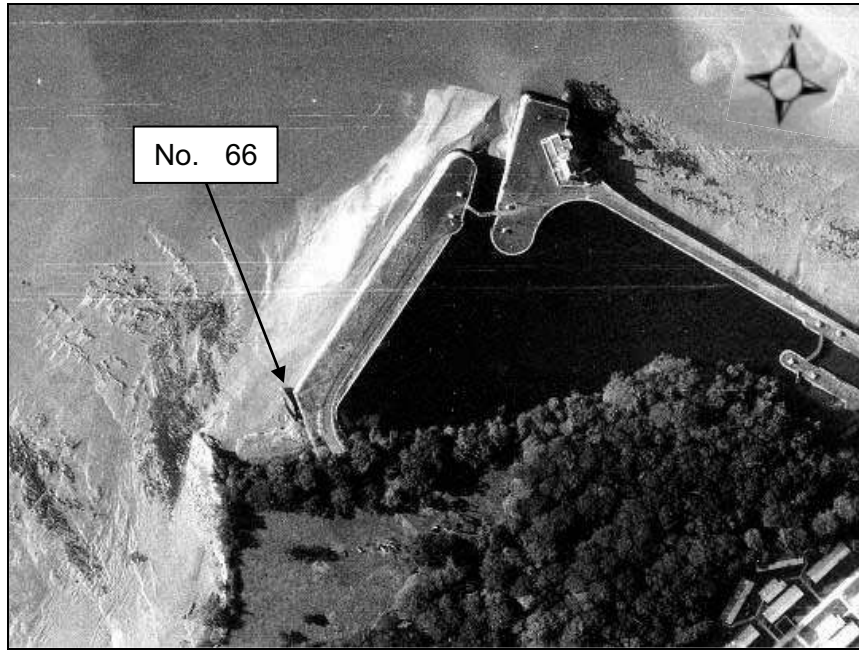
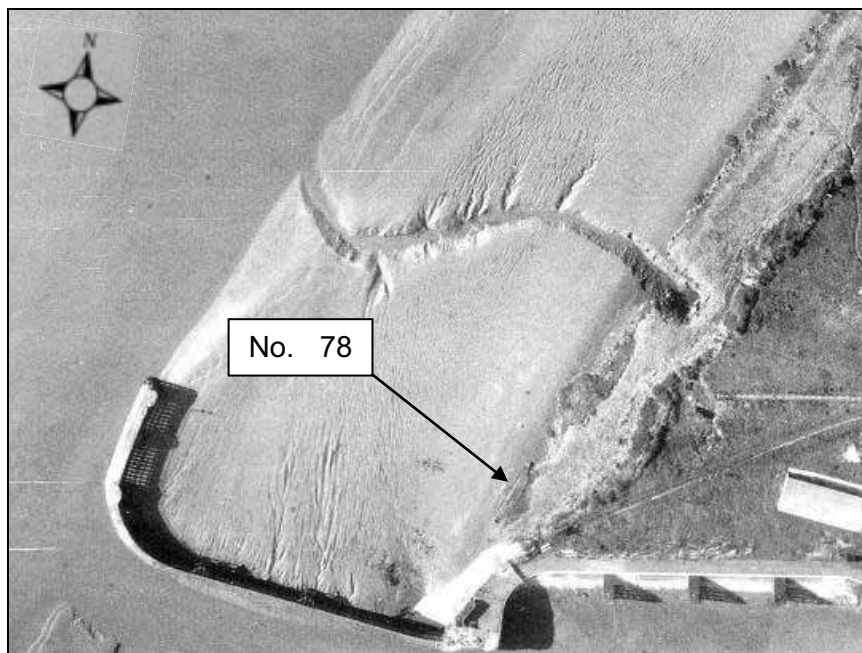
Figure 11. The two wrecks at Sharpness Docks.

The top photograph (Figure 11a) shows vessel No. 66 (*Alaska*), and the bottom photograph (Figure 11b) shows vessel No. 78 (*Tribune*), both visible in 1945. (NMR RAF/106G/UK/733 3052 26-AUG-1945 © English Heritage (NMR) RAF Photography).

Further south on the east bank were two wrecks (Figure 11) which were also mapped as part of this study (vessel Nos. 66 *Alaska* and 78 *Tribune* (after Barnett 2008). Both were visible on 1945 aerial photographs, but not those taken subsequently. Paul Barnett has provided further details regarding the history of these vessels. They were abandoned and then broken up. The *Alaska* keel eventually drifted off the bank c. 1977 and the remains of the WWI Cruiser *H.M.S. Tribune* were eventually buried after the majority of her steel was recovered by local scrap merchants c.1922 (L. P. Barnett pers. comm. 2009).

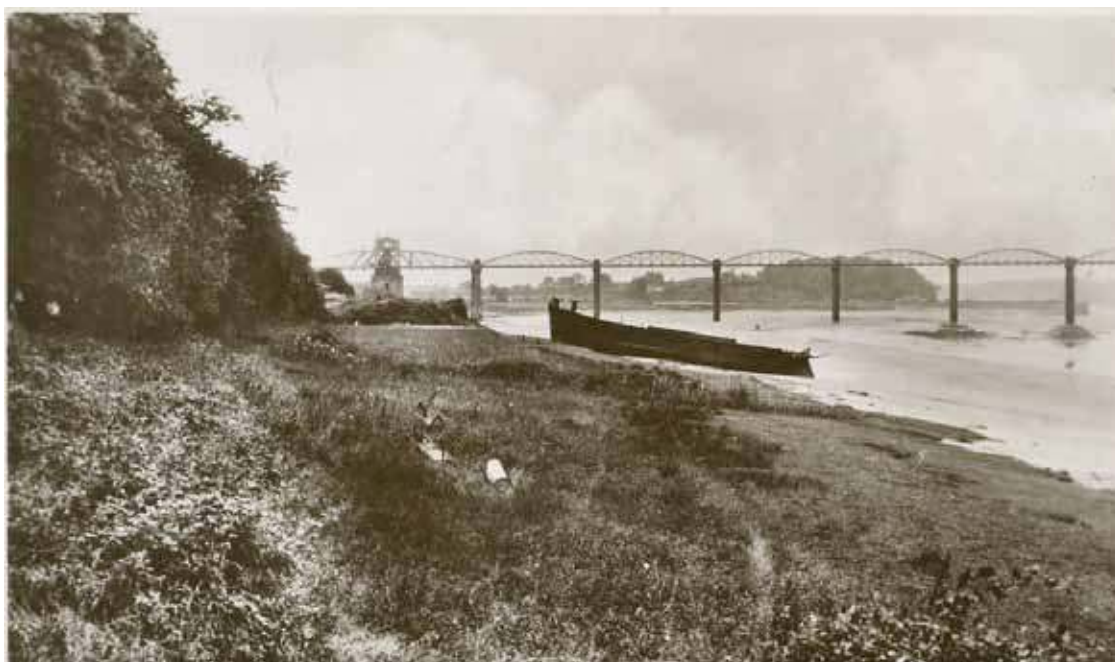
Figure 14. Late 1940s? photograph looking south towards the railway bridge

Photograph reproduced courtesy of Pat Greatorex. Note the build up of dredging material to the north of the railway bridge. Vessel 38 (*Selina Jane*) is visible in the middle ground.

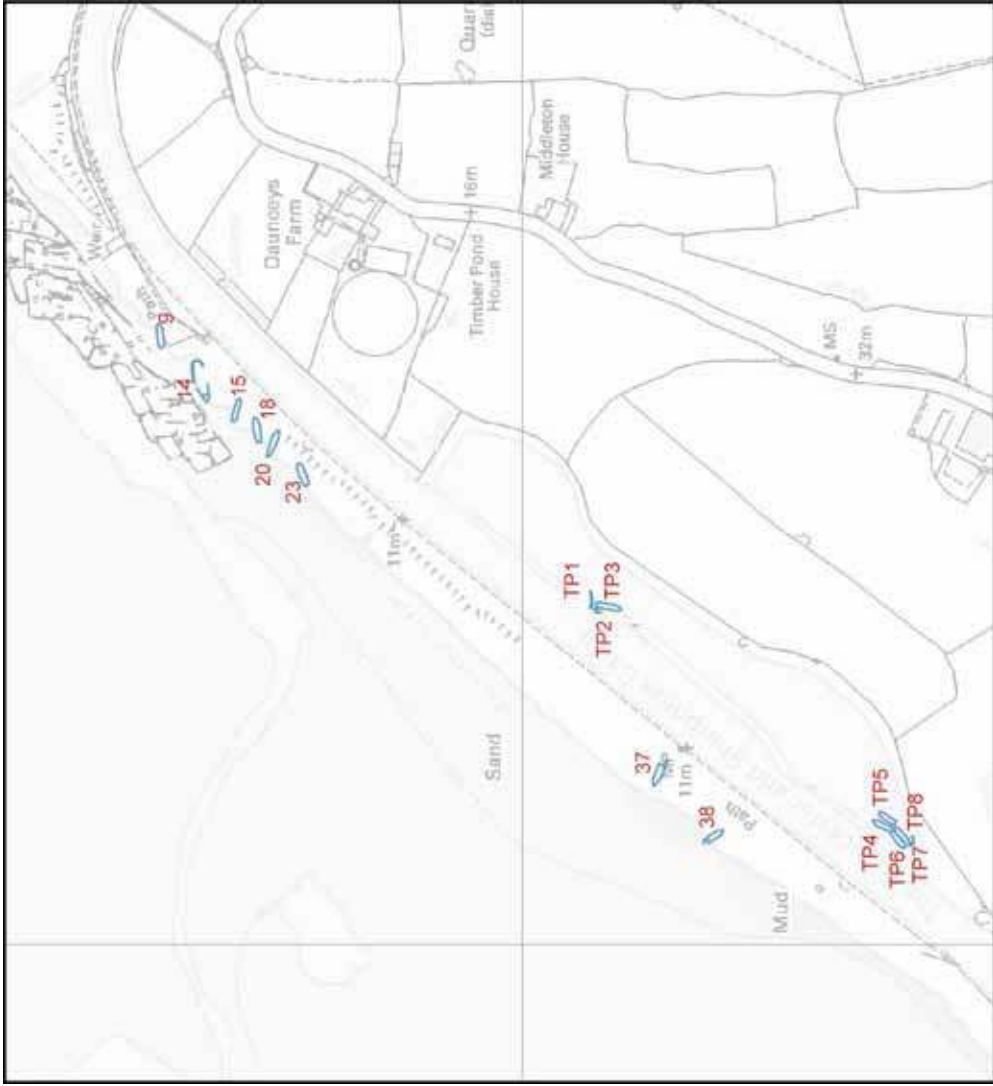
Figure 15. Purton vessels visible in 1945

The beached vessels on aerial photographs of 1945. The numbers correspond to those given in Fig. 2 and Table 1. (Base Map © Crown copyright, All rights reserved. Gloucestershire County Council 100019134 2010).

Sixteen vessels were identified on aerial photographs taken in 1945 (Figures 4-5), including several within the ship canal which are believed to have been beached following a bank collapse on the eastern side of the canal into the adjacent timber pond in February 1912 (L. P. Barnett pers. comm. 2009) (Figure 15).

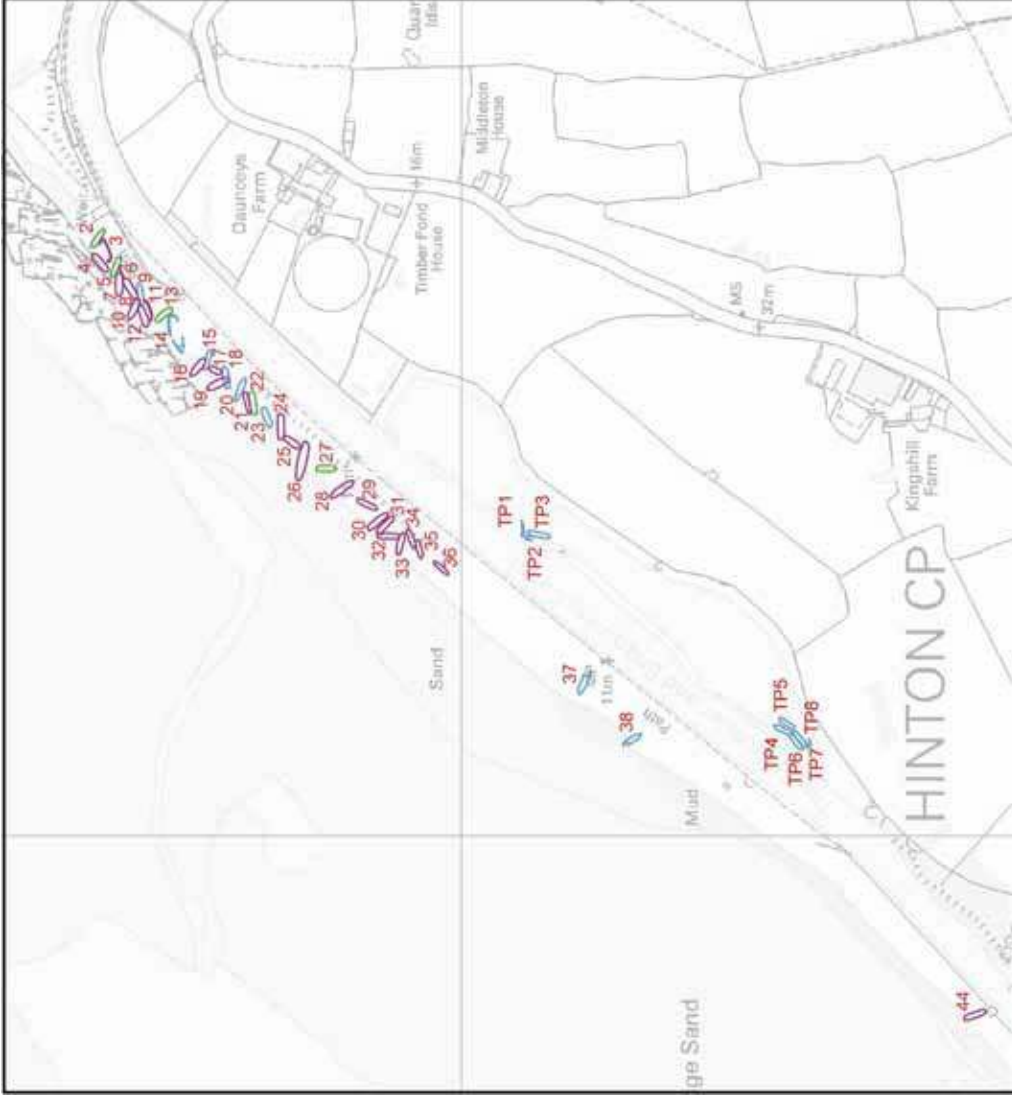
Figure 17. Purton hulks visible in 1969

The vessels in blue depict the hulks still visible from the 1945 aerial photographs, whilst those in green are the hulks still visible from the 1946 aerial photographs. Those in pink are the hulks first visible on aerial photographs taken in 1969. The numbers correspond to those given in Fig. 2 and Table 1. (Base Map © Crown copyright, All rights reserved. Gloucestershire County Council 100019134 2010).

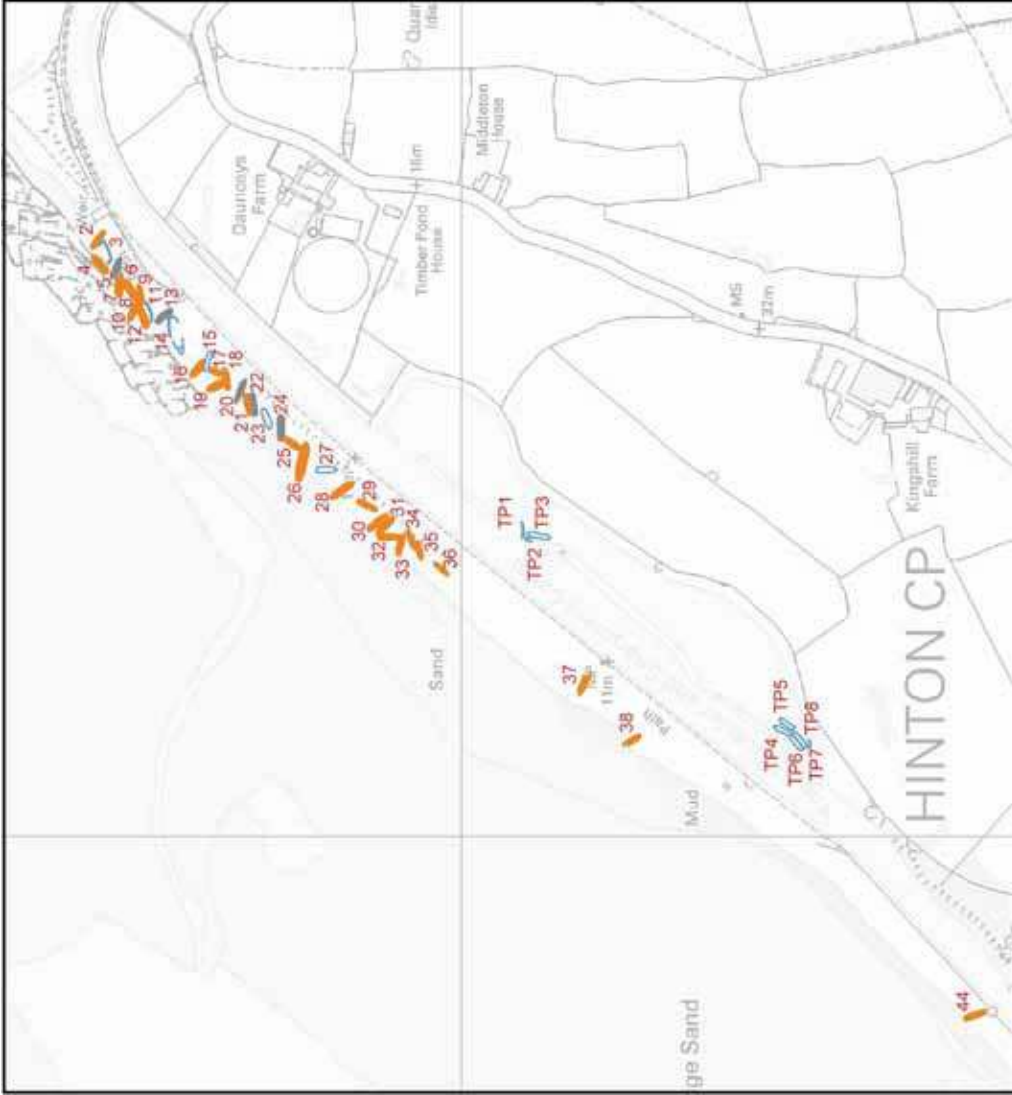
Figure 18. Purton hulks visible in 1979.

The vessels in orange indicate that they are more than 50% visible on aerial photographs. Vessels in grey indicate that they are partially or less than 50% visible on aerial photographs. Those with a blue outline only are not visible on the aerial photographs taken in 1979. The numbers correspond to those given in Fig. 2 and Table 1. (Base Map © Crown copyright, All rights reserved. Gloucestershire County Council 100019134 2010).

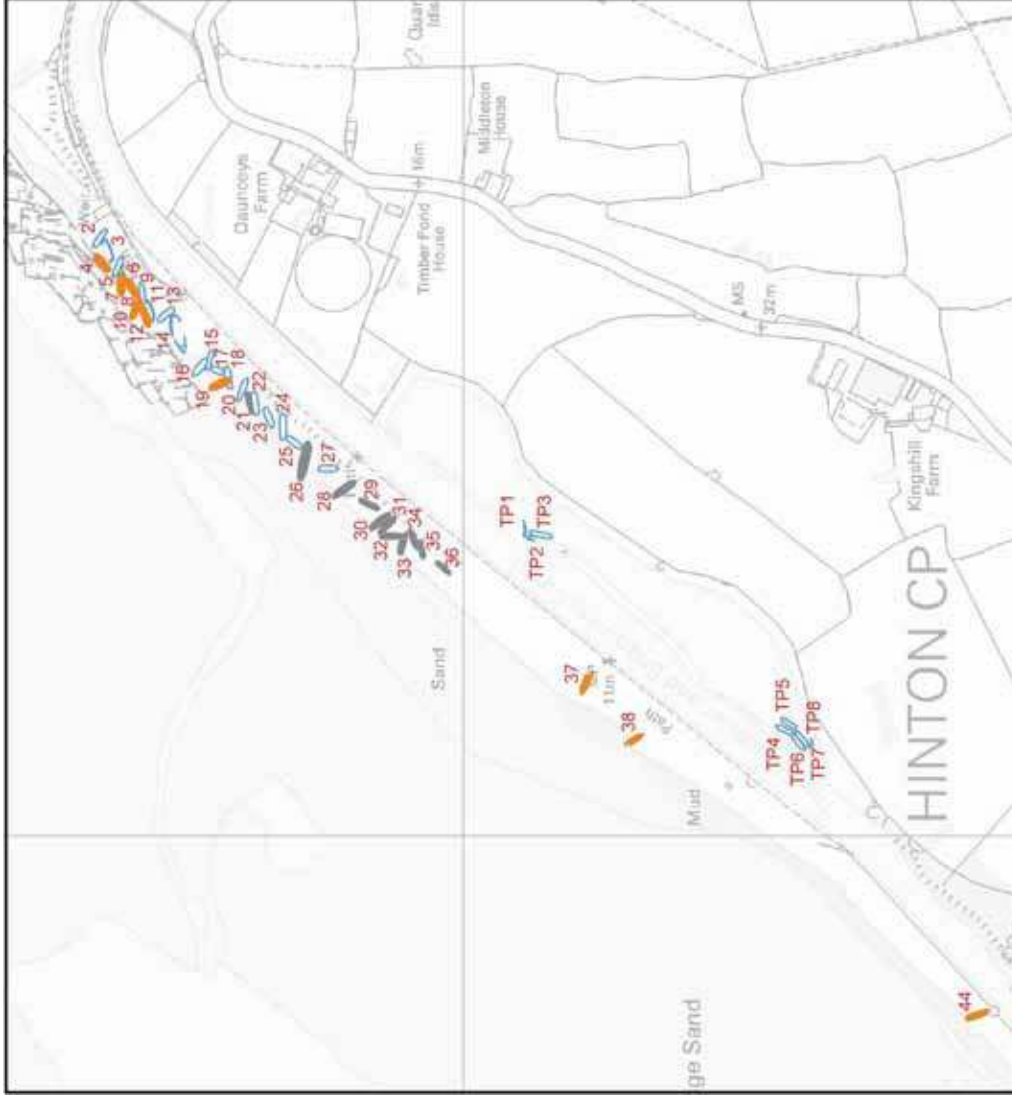
Figure 21. The Purton hulks in 2007.

The vessels in Orange indicate that they are more than 50% visible on aerial photographs. The vessels in Grey indicate that they are partially or less than 50% visible on aerial photographs. Those with a blue outline only are not visible on the aerial photographs from 2007. The numbers correspond to those given in Fig. 2 and Table 1. (Base Map © Crown copyright, All rights reserved. Gloucestershire County Council 100019134 2010).

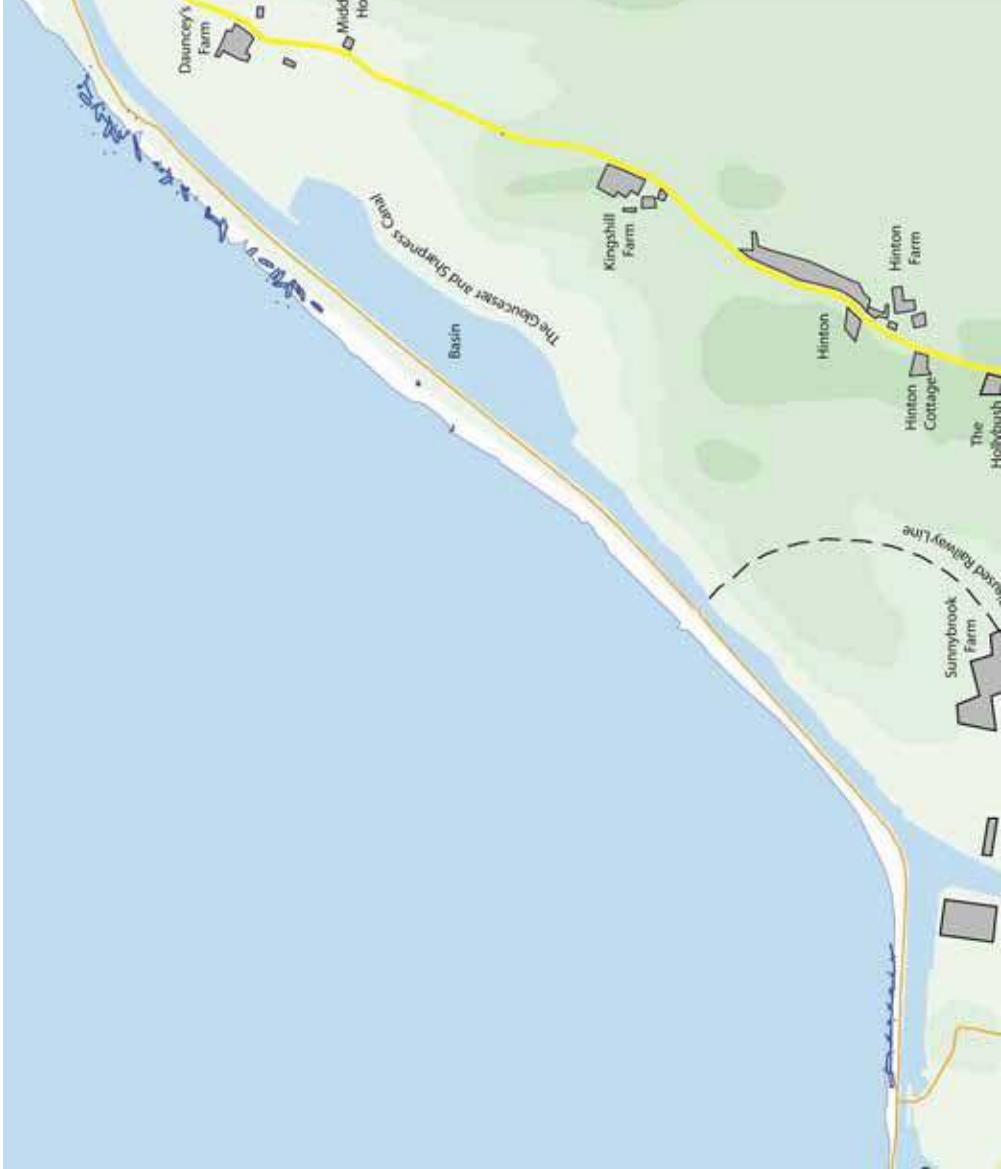
Figure 22 The GPS survey of 2009

The GPS survey indicates all vessels visible on the ground in 2009. Results kindly supplied by Laurie Coleman. (Base Map © Crown copyright, All rights reserved. Gloucestershire County Council 100019134 2010).
