**Recording of a weir
at Purton,
Gloucester and Sharpness Canal**

Martin Cook BA MIFA

20th January 2010

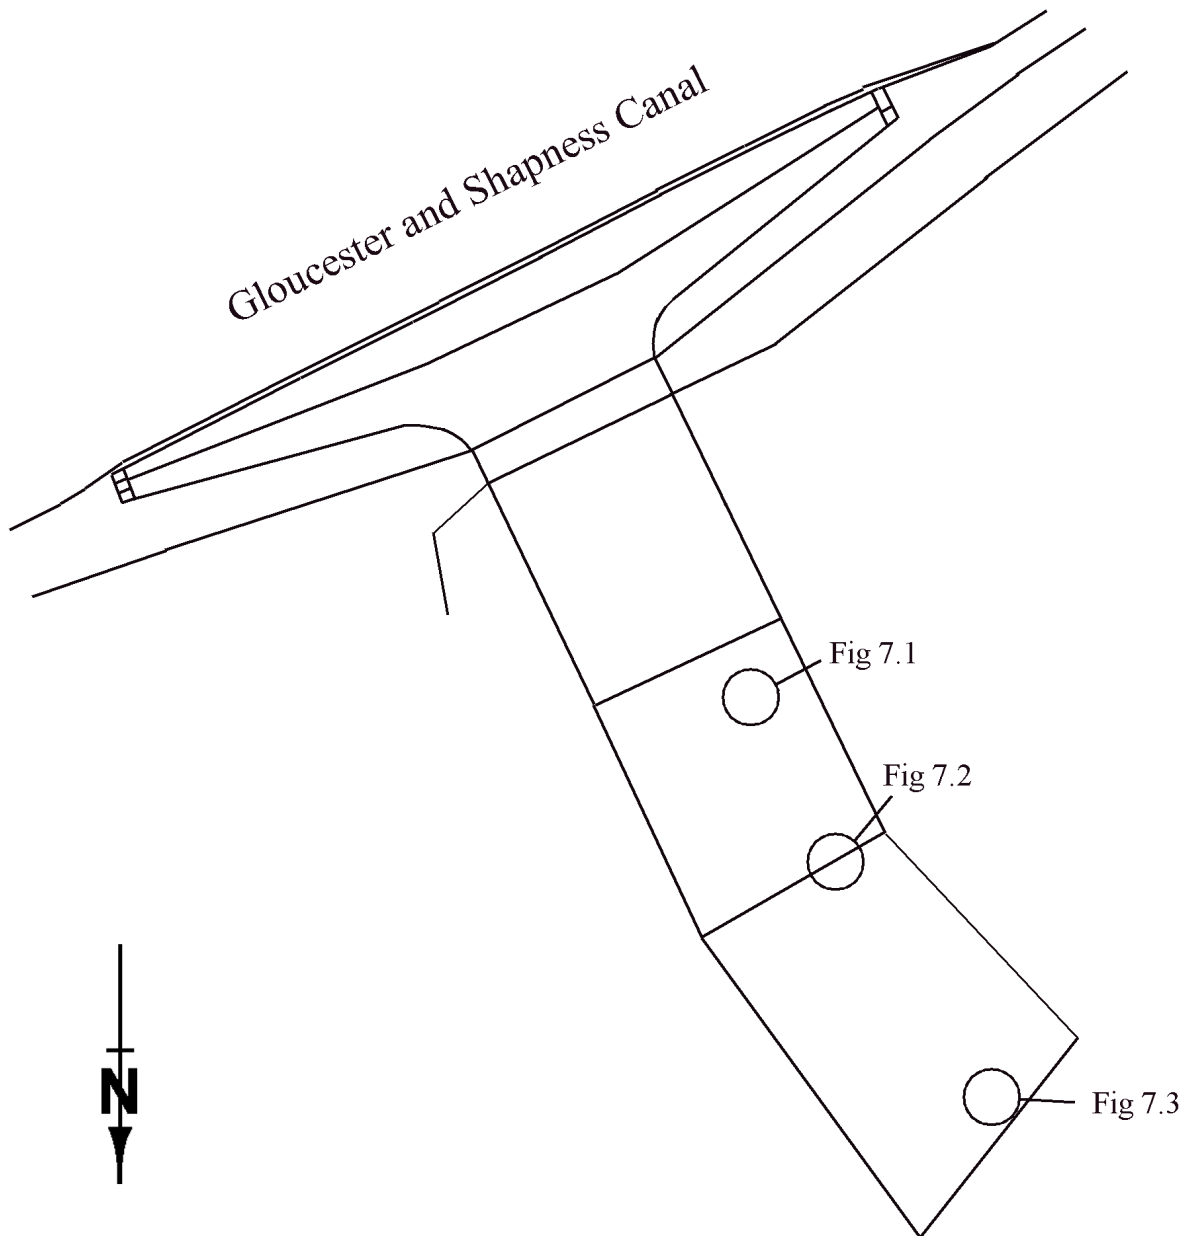
Fig 6: Locations of recorded elements of Purton Weir - Figures 7.1 to 7.3

It was agreed that a sample of each different component of the stonework would be drawn, supplemented by photographs of the various structural components as seemed appropriate. It was apparent that the weir bed was constructed in three different sizes of stone, increasing in size from south to north, as the discharge end of the weir was approached. Consequently, three discrete areas were recorded (Fig 6).

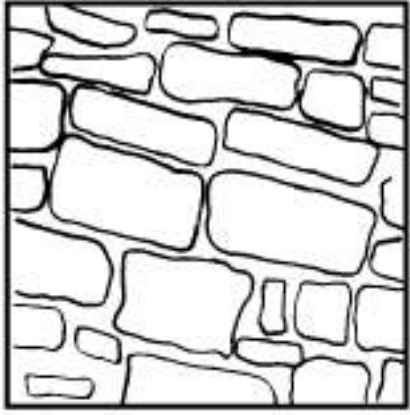
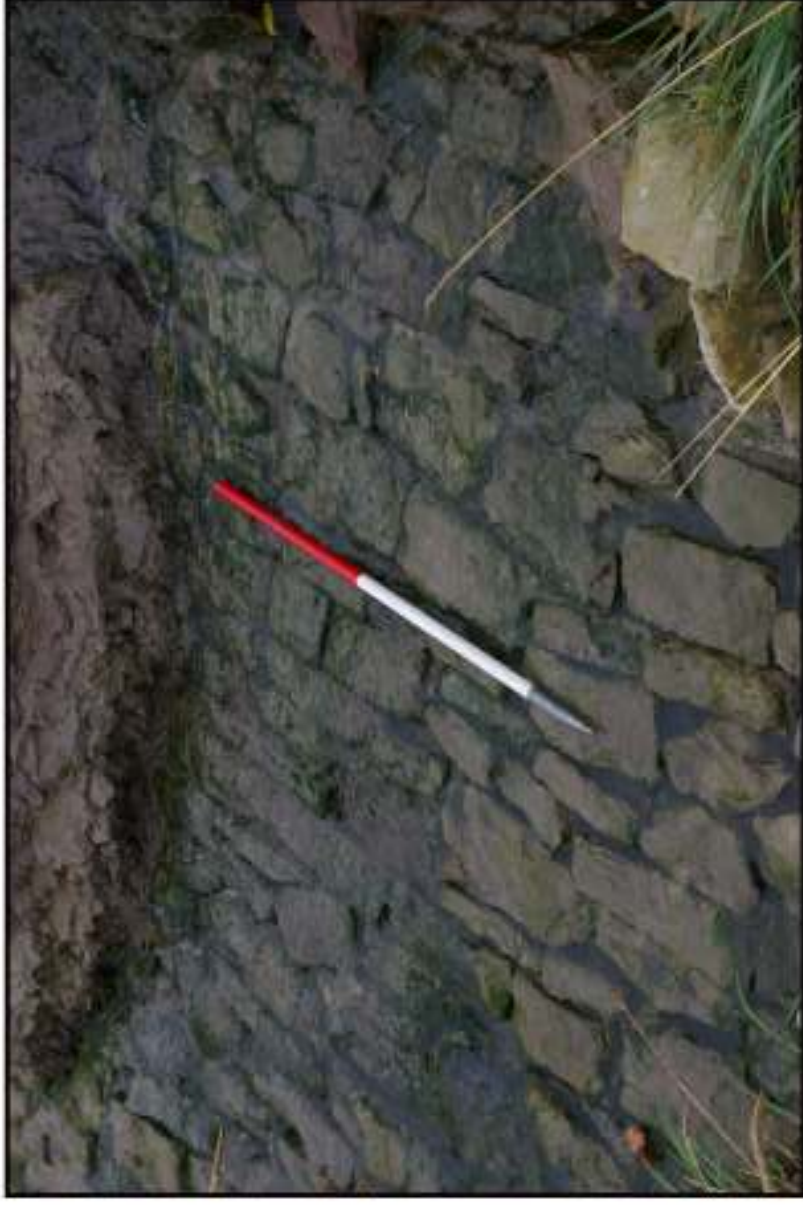
The area of the weir comprising the smallest stones, varying in length from 0.3m to 0.5m and in width from a little less than 0.1m to around 0.2m, was found in the section below the weir head (Fig 7.1). These gradually increased in size and regularity to become, consistently, *c* 0.5m long and *c* 0.2m wide by the lower half of this section. The stone was laid in unmortared courses, perpendicular to the flow of the water and retained at its lower side by a transverse baulk of timber approximately 0.2m square (Fig 7.2). This was secured in place by a number of square-headed anchors.

Fig 7.1. Typical stone arrangement near top of weir

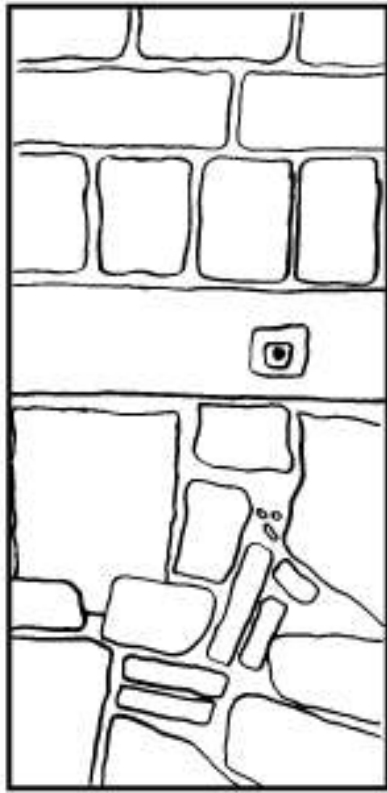
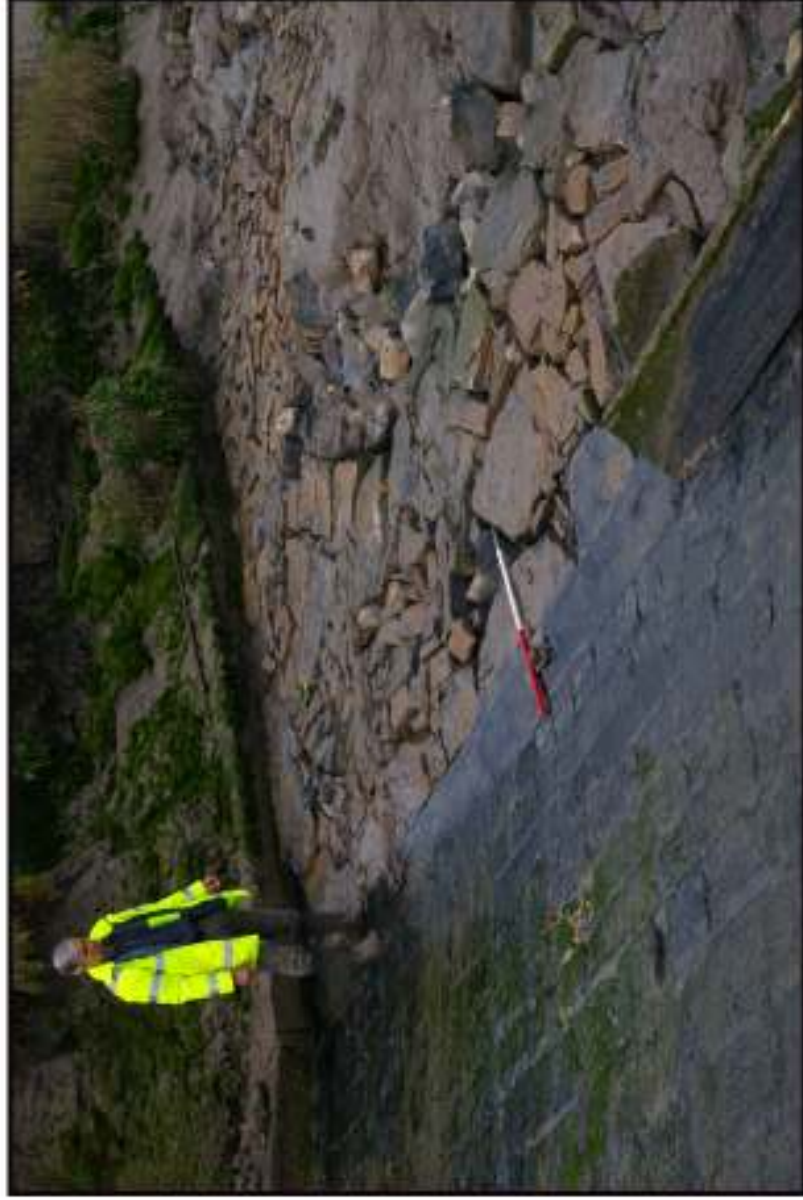
Below this was an area of stone of much more widely variable size (Fig 7.2), being from 0.3m long by 0.1m wide, all the way up to stones in excess of *c* 1m across. These were again unmortared and retained in place at their lower end by a transverse baulk of timber approximately 0.2m square, secured in place by a number of square-headed anchors (Fig 7.3).

Fig 7.2: Typical stone arrangement near middle of weir

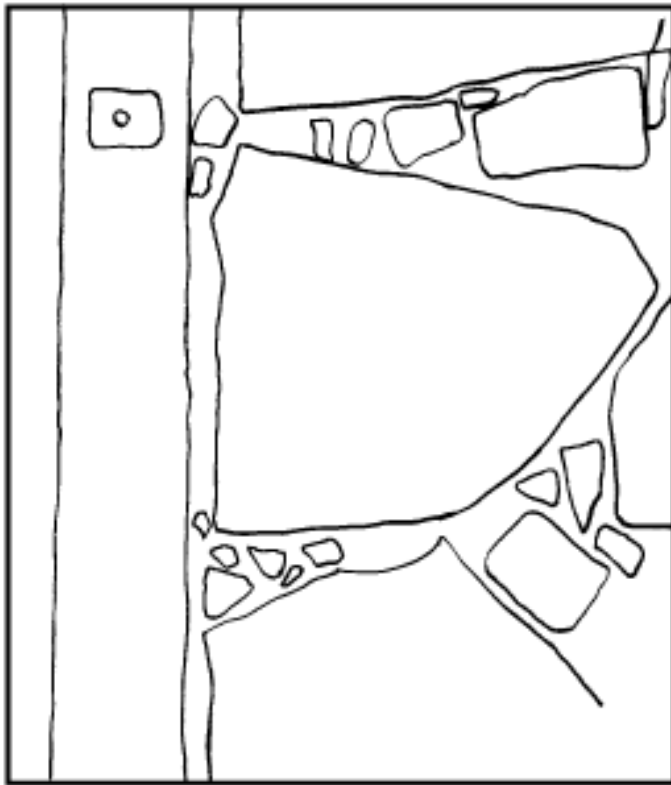
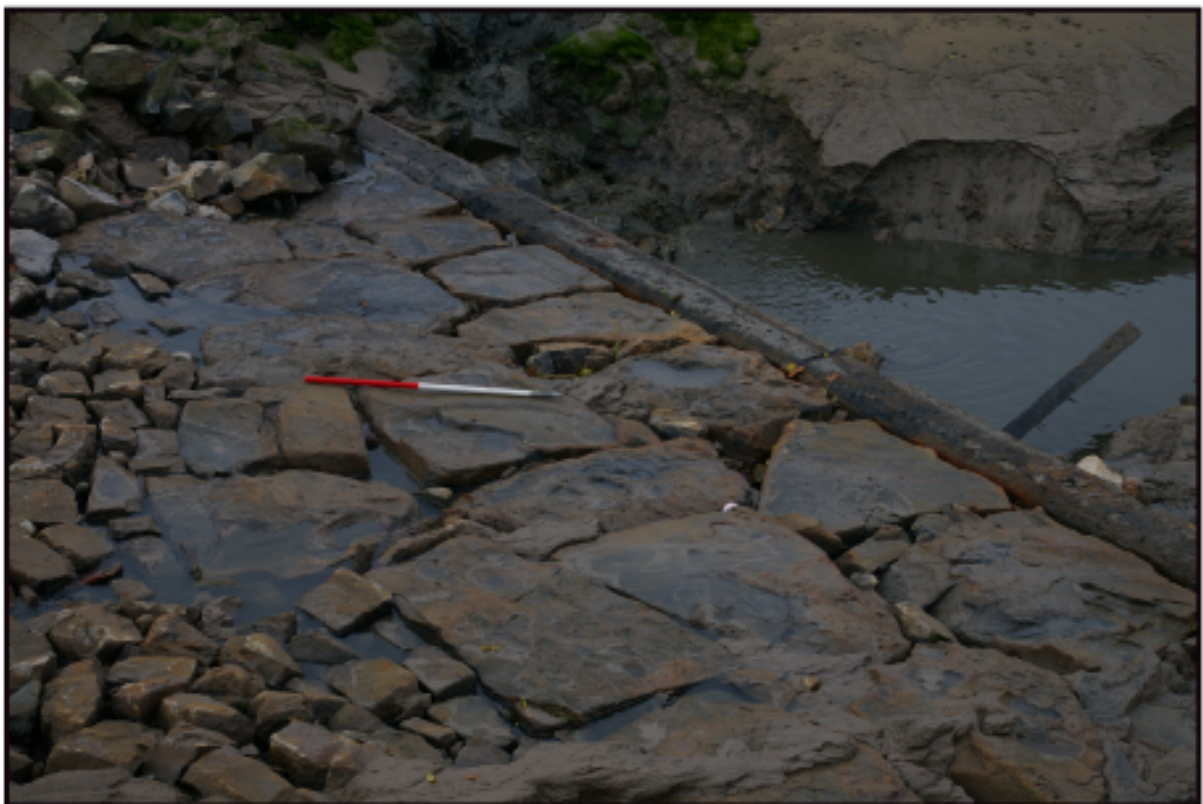
Fig 7.3: Typical stone arrangement near bottom of weir
